Inspection Report
1234 Any Street
Longmont, CO 00000
Prepared for: Mr. John Doe

Prepared by: Advantage Home Inspections, Inc.
303-881-1241 Fax: 303-776-8723

July 00, 2013

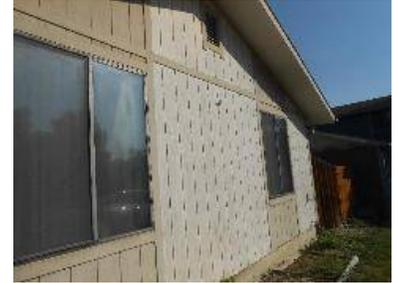
Exterior paint at end of expected life. It is recommended that the house siding be sanded/scraped, primed and painted.

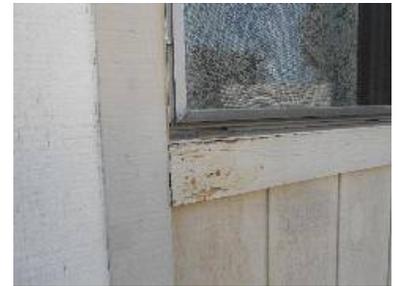
Loose material noted at window and door trim. Repair needed to limit further damage.

Gaps noted around window and door trim. Repair or replace caulking around exterior window frames to prevent moisture intrusion or air infiltration.

Scrape, prime and paint loose or flaking finishes. This will protect trim from damage.

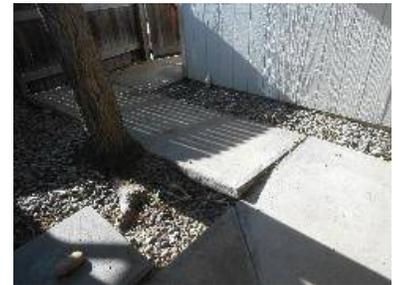
TYPE: Concrete.
CONDITION: Surface raised/settled, Tripping hazards. Repair or replacement needed.
Recommend a qualified concrete contractor inspect and make repair or replacement recommendations.

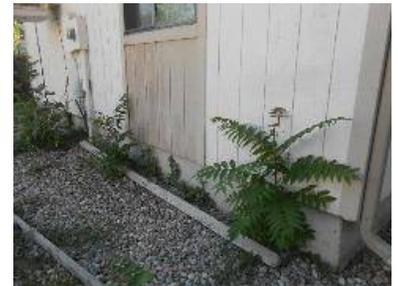
CONDITION: Landscape maintenance and weed control needed. Trees growing close to structure. Removal may be needed.

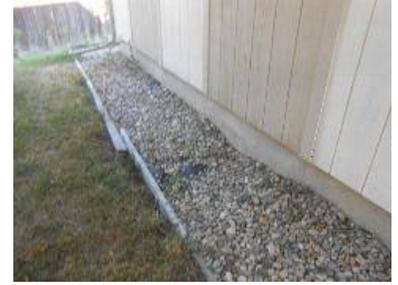
Gentle slope, Grade at foundation needs correction. Some areas around the house have flat to negative slope. Poor slope can cause run-off water to pool at foundation and concrete flatwork. This can lead to moisture penetration through walls and possible damage to concrete walls, patios and related structures. Pitch slope of soils away from foundation. Slope should fall away from the foundation at a minimum of 1/2 inch per foot and extend at least 6 feet away from the foundation.

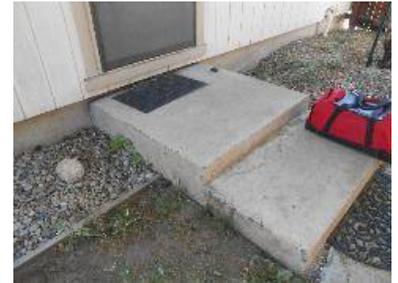
Main entrance stoop raised/settled, Tripping hazards. Repair or replacement needed. Recommend a qualified concrete contractor inspect and make repair or replacement recommendations.

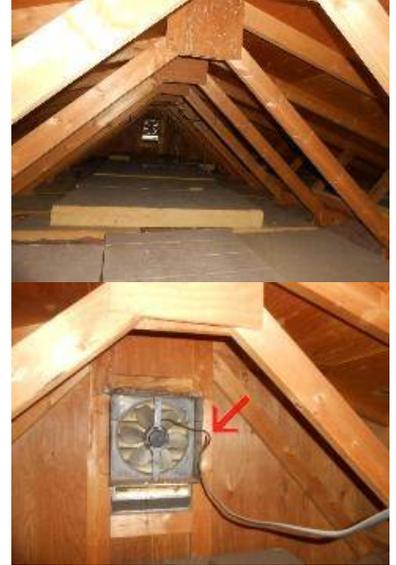
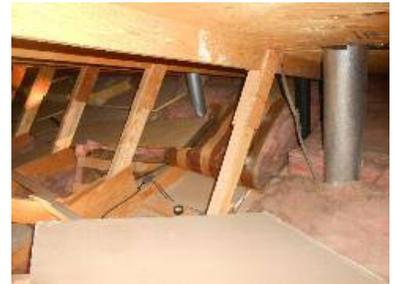
Insulation has been disturbed and good coverage is no longer present, Recommend additional insulation in attic area. Current building practices require a r-value of 38, for our climate increasing the total R-value to 50 is considered the most effective.

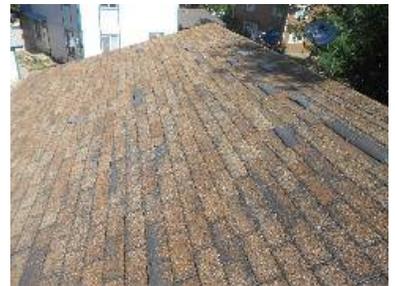
ROOF ACCESS: Walked on roof.
ROOF COVERING STATUS: Granular loss, Cracking and clawing of shingles are the result of long term weathering and an advanced shingle age. Roof at the end of its useful life, Anticipate the need to replace the roof covering. A licensed roofing contractor should be called to make further evaluation and replacement recommendations.

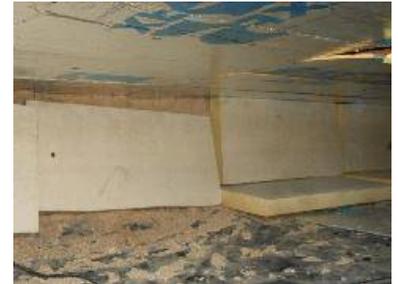
Due to insulation covering walls a complete interior inspection of the foundation was not available.

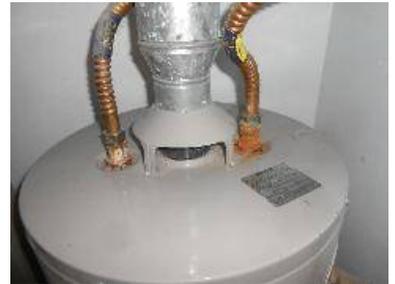
Defects noted, There is corrosion on the water line connections. This is an early warning of future failure. It may not be currently leaking, but it will need to be replaced in the near future.

Temperature for water heater set on low. I raised temperature to observe flame but unit did not fire. Could be a problem with gas control or thermocouple.

I recommend that a licensed and insured plumber inspect and make repair or replacement recommendations.

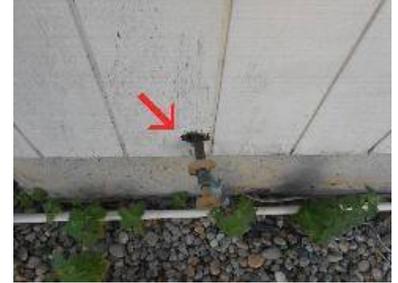
Rear hose faucet sets proud of wall. Recommend adjustment so faucet is flush with wall to limit freeze hazard.

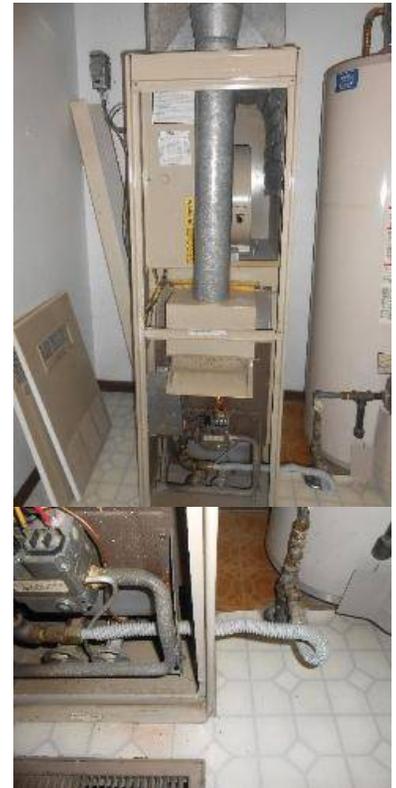
APPROXIMATE AGE IN YEARS: The furnace appears to be 33 years old. The life expectancy of a forced air furnace is 18-20 years. This furnace's age is beyond its design life. Further evaluation and replacement recommendations will be needed by a licensed and insured HVAC contractor.

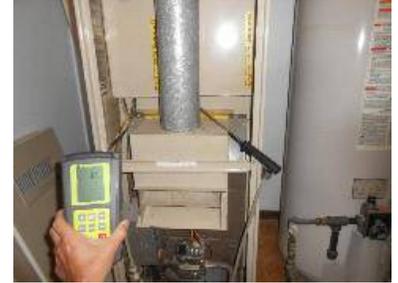
During testing of furnace I detected a Dangerous carbon monoxide reading. I detected a carbon monoxide reading of 75-86 ppm at furnace draft hood connection. The EPA states that prolonged exposure (12 hours or more) to carbon monoxide at 9ppm can be a health hazard. The furnace should not be used until repair or replacement is made! Contact a licensed and insured heating contractor for further evaluation and repairs as needed.

Due to age of system and related safety concerns a heat exchanger leak test by a licensed HVAC contractor is recommended.

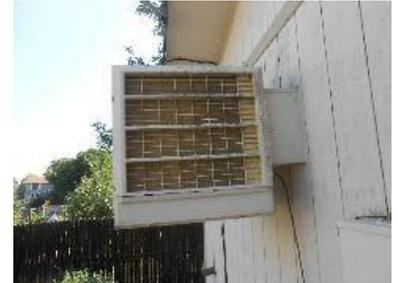
System is water supply is off. I was unable to test operation.
Media filter is deteriorated and should be replaced.
Recommend inspection and evaluation of the performance of system by a qualified service technician.

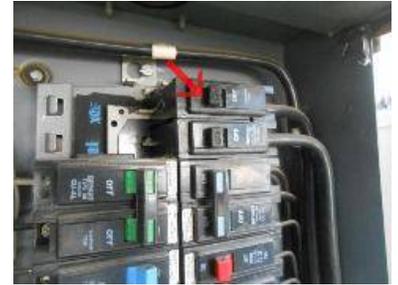
Missing 220 volt handle tie. No handle ties are present between two single pole breakers that are servicing the main electric disconnect. This is a electrical shock hazard. As on breaker could trip while leaving system still energized. Recommend a licensed electrician make further evaluation and corrections as needed.

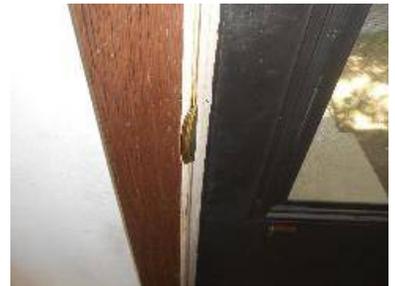
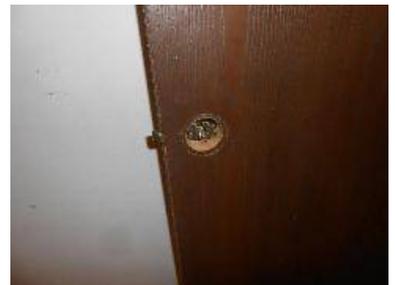
The door or hardware needs some adjustment or repair to function appropriately. The doorknob assembly needs to be replaced.

Damage noted at west bedroom door jam. Make repairs as needed.

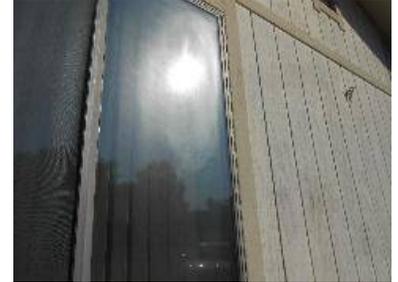
TYPE: Aluminum, Insulated glass with storm windows, Sliding.
CONDITION: Approximately 3 windows have condensation or condensation residue between window panes. This indicates a broken seal between windows. Generally considered a cosmetic problem. Only known repair is for the glass unit of the window be replaced. Further evaluation by a qualified window repair/replacement company is recommended.

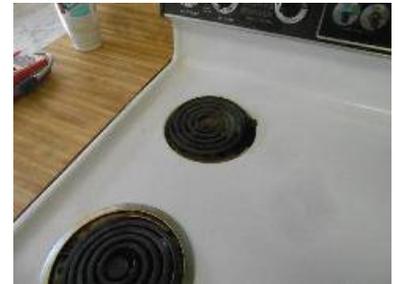
Drip pan missing at rear burner, replacement is needed.

Anti-tilt bracket missing at range. This can cause range to fall forward if forced is placed on open oven door. Recommend installing anti-tilt bracket to prevent personal injury.

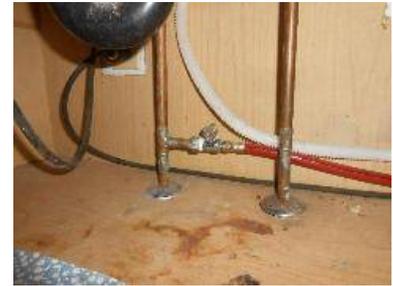
Appears operational. It is an older model appliance, at or near end of it's useful life. Anticipate replacement of unit in near future.

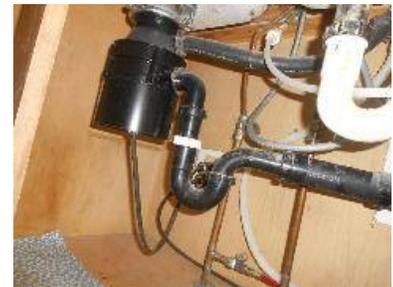
A p-trap is installed at disposal discharge. This is generally not recommended as the trap will reduce water flow and lead to back-ups. Recommend consulting with licensed plumbing contractor for best method of repair.

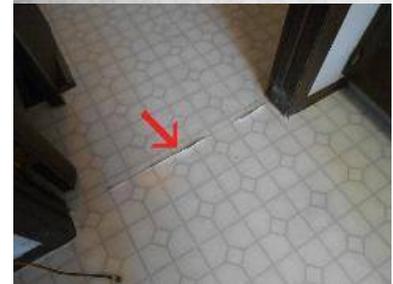
Floor covering is vinyl/linoleum.
Wear noted with loose seam at utility room threshold.
Repair or replace as needed.

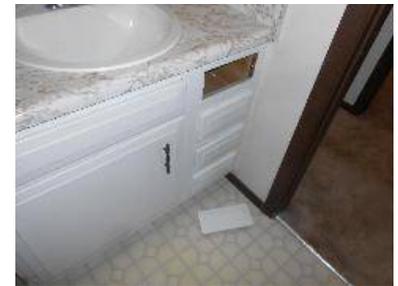
Vanity Cabinet:	The vanity cabinet in this bathroom is damaged and requires repair or replacement.

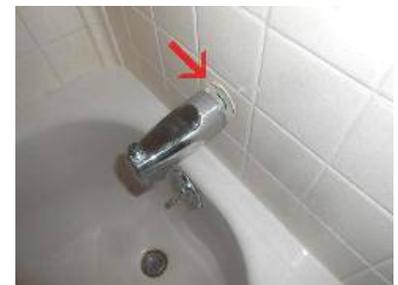
Basin and Drain Fixture:	Satisfactory - The basin and drainage fixture appears to be satisfactory.
Faucet and Supply Lines:	Satisfactory - Faucets and supply lines appear satisfactory.
Toilet Condition:	Satisfactory - The toilet in this bathroom appears to be functional. No leaks and proper operation was noted during inspection.
Tub:	Steel Tub OK - The bathtub is a steel material with a solid finish applied. It appears to be in satisfactory condition.
Tub Mixing Valve & Stopper:	Tub spout sets proud of wall. Recommend adjustment so spout is flush with wall to limit moisture intrusion into wall cavity.

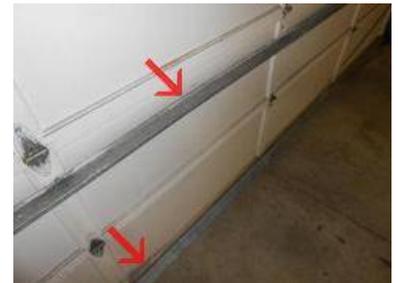
Overhead Door and Hardware Condition: The overhead door needs repair. Support bracing on inside of door is loose and cracked. Recommend that the doors be inspected and repaired by a qualified garage door company.

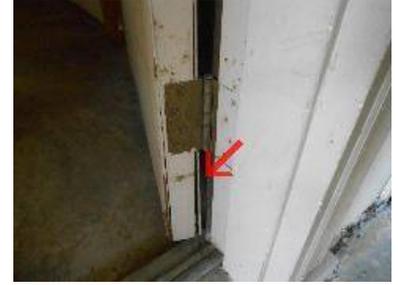
There is no deadbolt installed on the entry door. Consideration should be given to installing a deadbolt as a safety feature.

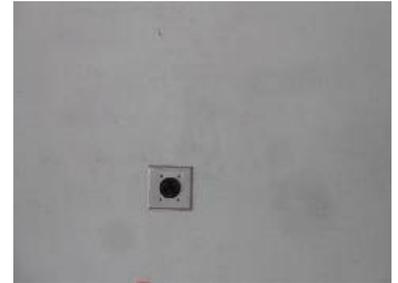
There is a 220volt outlet in garage. No dedicated 220volt breaker was observed for this outlet. Unable to determine is outlet is energized. Outlet could be spliced off of other 220volt circuit which would be a fire hazard. Recommend further evaluation by a licensed electrician.

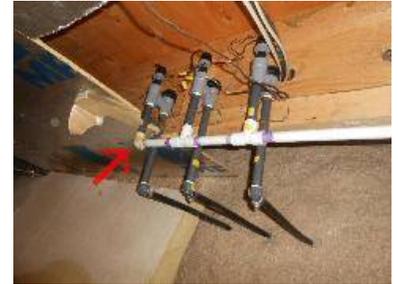
The control valves for irrigation system are located in crawlspace. The west valve manifold water supply was off however there was a water leak at one of the pipes. Recommend repair to leaking pipe and repair or replacement of shut-off valve so it will fully operate. Recommend that a qualified landscape contractor or plumber inspect and make any necessary repairs to the system.
