Inspection Report
1234 Any Street
Longmont, CO 00000
Prepared for: Mr. John Doe

Prepared by: Advantage Home Inspections, Inc.
303-881-1241 Fax: 303-776-8723

July 00, 2013

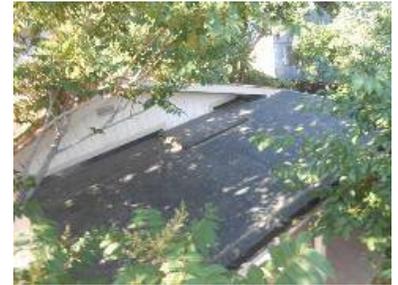
Appears serviceable.

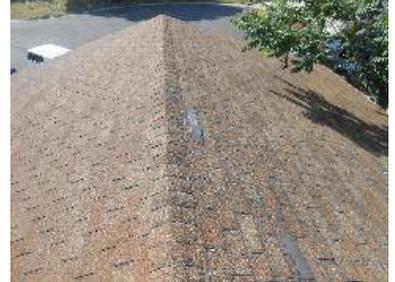
ROOF:

4. Granular loss, Cracking and clawing of shingles are the result of long term weathering and an advanced shingle age. Roof at the end of its useful life, Anticipate the need to replace the roof covering. A licensed roofing contractor should be called to make further evaluation and replacement recommendations.

STYLE: Gable.
TYPE: Composition shingles.

ROOF ACCESS: Walked on roof.
ROOF COVERING STATUS: Granular loss, Cracking and clawing of shingles are the result of long term weathering and an advanced shingle age. Roof at the end of its useful life, Anticipate the need to replace the roof covering. A licensed roofing contractor should be called to make further evaluation and replacement recommendations.

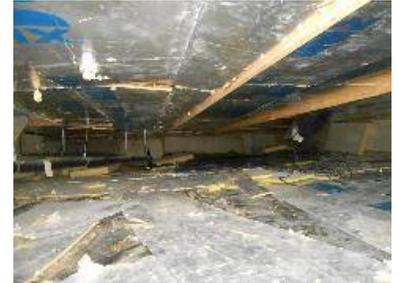
ACCESSIBILITY:

The house has a crawlspace under the first floor. Crawlspace was is fully accessible.

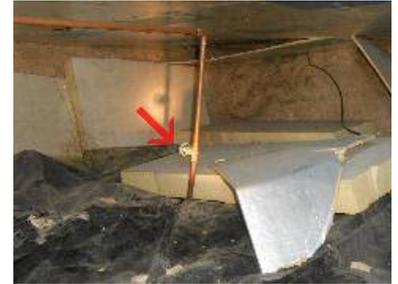
**MAIN WATER
SHUT-OFF LOCATION**

Crawlspace.

Copper.
3/4" water service line as it enters house.
Appears serviceable.

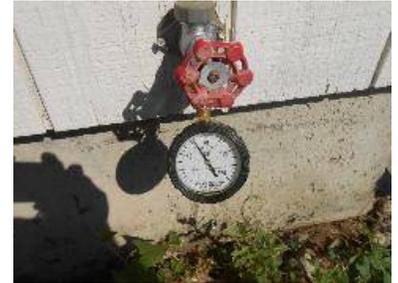
The water pressure at the front hose faucet tested at 65 psi during the inspection. The water pressure at the hose faucet tested between 60 to 80 psi which is considered normal for residential water supply systems. The water pressure was tested at the front hose faucet only and may not reflect the pressure at other fixtures and appliances within the house. Testing of water pressure at each fixture is beyond the scope of this inspection.

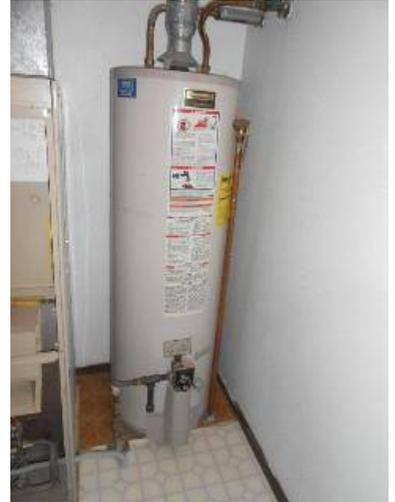
Gas, Direct fired storage tank.
Utility room.
40 Gallons, 35,500 Btu's.
Make : Kenmore
Model Number : 153.336413HA
Serial Number : A011474468.

Water heater appears to be 12 years old. The expected design life of a water heater is between 10 and 13 years.

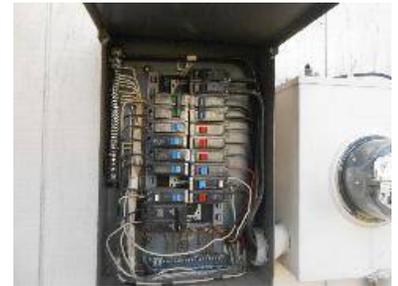
**ACCESSIBILITY:
MAIN PANEL
LOCATION AND
NOTES:**

Good - The electrical panel is in a location that makes it readily accessible. Exterior of house.

Appears serviceable. Wiring in breaker panel in good condition. No damaged or discolored wiring viewed. Circuit and wire sizing correct so far as visible. Grounding system is present and appears serviceable.

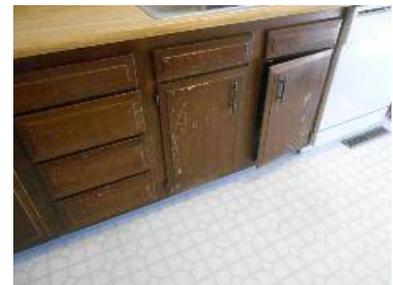
COUNTERS AND CABINETS:

Counters are Formica (plastic laminate), Appear serviceable.
Cabinets appear serviceable, with moderate to heavy wear.

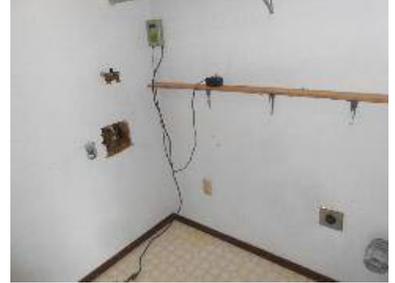
LOCATION: Service area main floor.

CONDITION: Plumbing appears serviceable.
220volt service appears operational.
Dryer vent is provided.

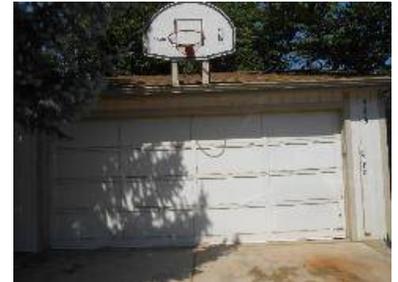
GARAGE:

Garage Type: The garage is detached and freestanding.
